ACOUSTICAL PERFORMANCE TEST REPORT

AAMA 1801 SOUND TRANSMISSION LOSS TESTING ON A
NFD FRAME WITH KINETICS KWAD-49 DOOR

H9326.01-303-11-R0

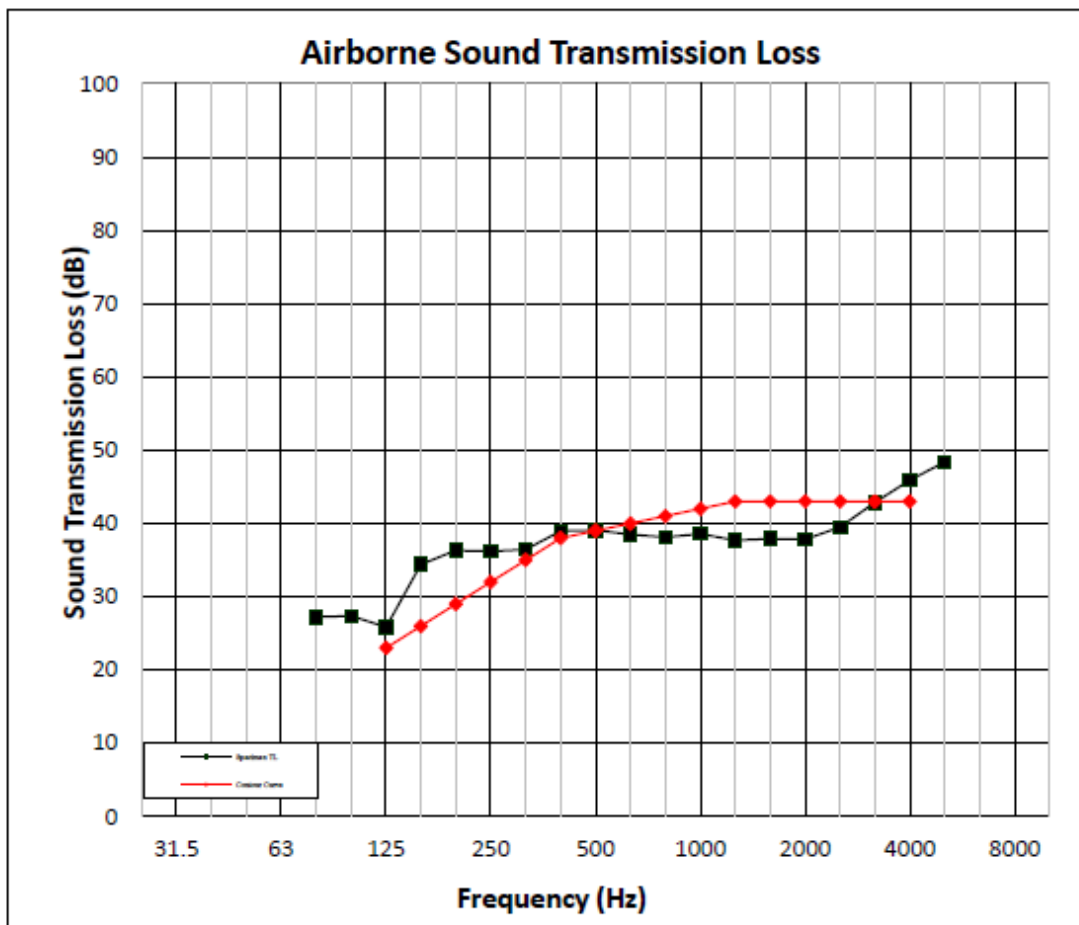
ASTM E90 AIRBORNE SOUND TRANSMISSION LOSS

TEST DATE	12/22/17				
DATA FILE NO.	H9326.01B3				
CLIENT	CR Laurence Co, Inc.				
DESCRIPTION	Series/Model: NFD Frame with Kinetics KWAD-49 Side Hinged Door with 1 row Pemko S773 head and jambs, 1 row NP600-CRL Door Frame Gasket head and jambs, 1 row Zero 475 head and jambs, and Zero 368 automatic door bottom				
SPECIMEN AREA	2.11 m ²	RECEIVE TEMP.	17.4 °C	SOURCE TEMP	17.8 °C
TECHNICIAN	Ryan R. Lau	RECEIVE HUMIDITY	33%	SOURCE HUMIDIT	31%

Transmission loss (TL) at each 1/3 octave frequency is the average source room sound pressure level minus the average receive room sound pressure level, plus, 10 times the log of the specimen area divided by the sound absorption of the receive room with the sample in place.

FREQ (Hz)	BACKGROUND SPL (dB)	ABSORPTION (m ²)	SOURCE SPL (dB)	RECEIVE SPL (dB)	SPECIMEN TL (dB)	95% CONFIDENCE LIMIT	NUMBER OF DEFICIENCIES
80	46.5	4.2	104	74	27	1.34	-
100	36.0	4.5	106	76	27	1.63	-
125	39.8	5.3	106	77	26	1.49	0
160	44.0	5.2	104	67	34	0.52	0
200	37.3	6.1	106	65	36	0.53	0
250	24.7	6.7	106	65	36	0.68	0
315	18.4	6.6	106	65	36	0.45	0
400	20.0	5.8	105	62	39	0.42	0
500	17.5	5.2	106	63	39	0.28	0
630	18.2	5.5	107	64	38	0.35	2
800	21.6	5.6	106	64	38	0.30	3
1000	9.4	5.9	107	64	39	0.24	3
1250	5.9	6.4	105	62	38	0.21	5
1600	5.2	7.3	103	60	38	0.22	5
2000	3.9	9.0	100	56	38	0.16	5
2500	3.7	10.8	100	54	40	0.35	3
3150	4.0	13.1	99	49	43	0.33	0
4000	4.6	17.3	97	42	46	0.49	0
5000	5.4	23.0	96	38	48	0.68	-
STC RATING	39 (Sound Transmission Class)						
DEFICIENCIES	26 (Sum of Deficiencies)						
OITC RATING	36 (Outdoor-Indoor Transmission Class)

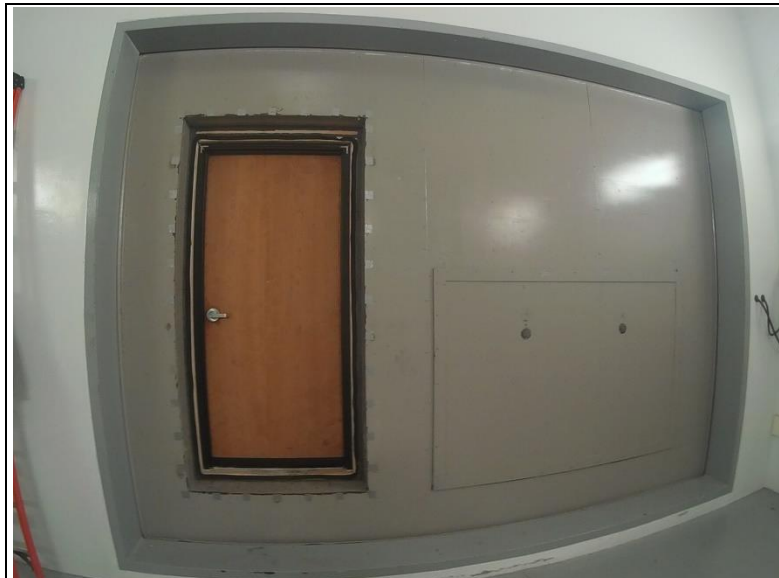
Photo No. 1
Source Room View of Installed Specimen

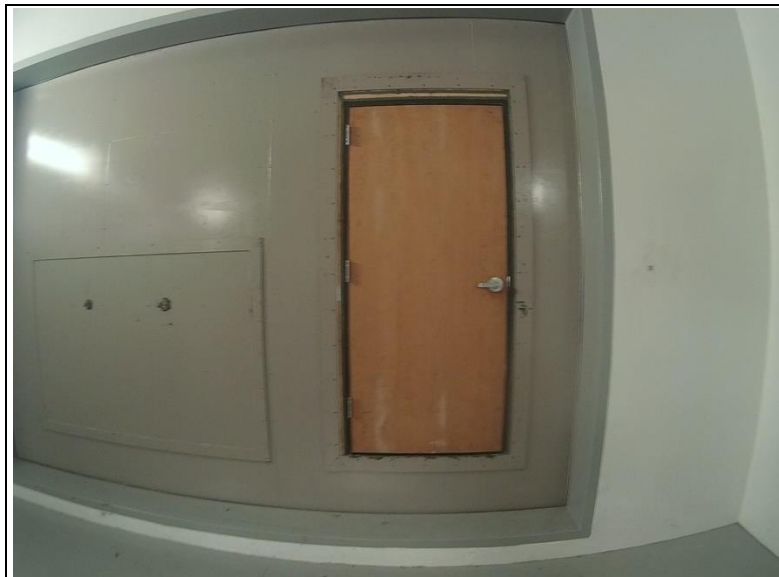
Photo No. 2
Receive Room View of Installed Specimen
