CR LAURENCE CO., INC.

ACOUSTICAL PERFORMANCE TEST REPORT

AAMA 1801 TESTING ON A NFD FRAME WITH ABS RIGICORE EX DOOR

H5843.02-303-11 R0

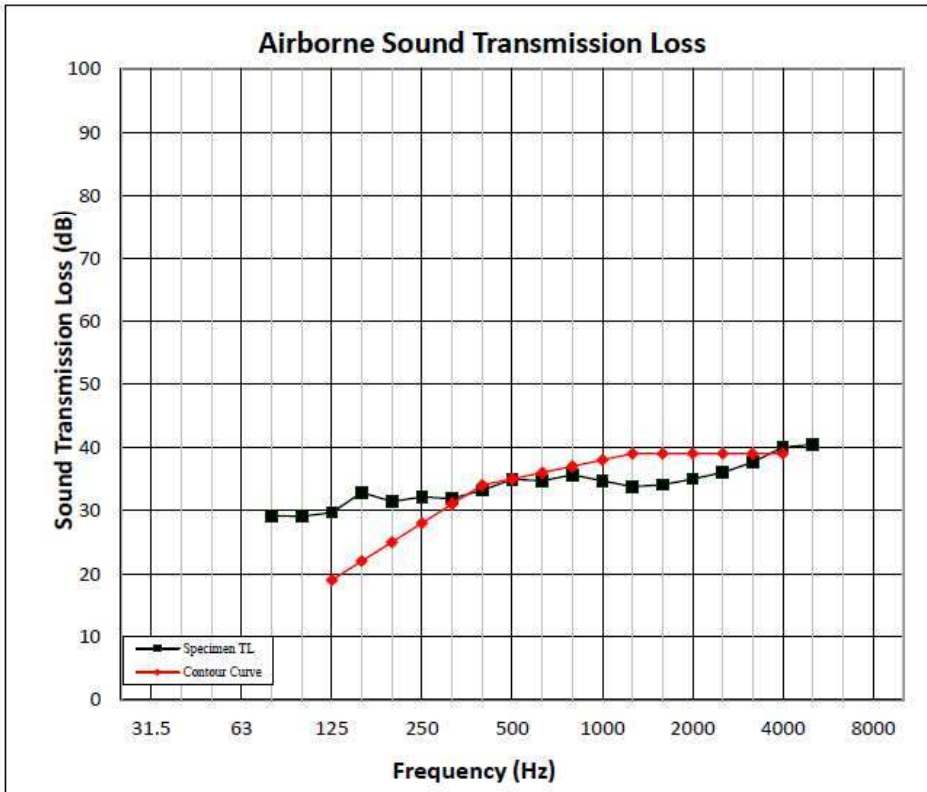
SECTION 11 RESULTS GRAPH

ASTM E90 AIRBORNE SOUND TRANSMISSION LOSS

DATA FILE NO.	H5843.01B				
CLIENT	CR Laurence Co., Inc.				
DESCRIPTION	Series/Model: NFD Frame with ABS RigiCore EX Door				
SPECIMEN AREA	2.10 m ²	RECEIVE TEMP.	19.4 °C	SOURCE TEMP	18.2 °C
TECHNICIAN	Leeland S. H	RECEIVE HUMIDITY	52%	SOURCE HUMIDIT	54%

FREQ (Hz)	BACKGROUND SPL (dB)	ABSORPTION (m ²)	SOURCE SPL (dB)	RECEIVE SPL (dB)	SPECIMEN TL (dB)	95% CONFIDENCE LIMIT	NUMBER OF DEFICIENCIES
80	44.3	4.4	103	72	29	1.37	-
100	34.1	4.8	104	73	29	1.67	-
125	37.4	5.2	106	73	30	1.39	0
160	42.5	4.9	104	69	33	0.47	0
200	35.4	6.3	106	70	31	0.50	0
250	21.9	7.2	106	68	32	0.59	0
315	18.7	6.8	106	69	32	0.50	0
400	19.1	5.8	105	68	33	0.46	1
500	18.3	5.3	106	67	35	0.17	0
630	18.9	5.6	106	67	35	0.32	1
800	20.3	5.7	106	66	36	0.36	1
1000	10.9	5.9	107	68	35	0.20	3
1250	10.6	6.1	105	66	34	0.13	5
1600	9.6	6.7	104	65	34	0.29	5
2000	7.2	7.8	101	60	35	0.20	4
2500	5.5	8.7	101	59	36	0.13	3
3150	5.5	9.9	101	56	38	0.35	1
4000	5.5	12.1	99	51	40	0.36	0
5000	5.7	15.2	99	50	40	0.42	-
STC RATING	35	<i>(Sound Transmission Class)</i>					
DEFICIENCIES	24	<i>(Sum of Deficiencies)</i>					
OITC RATING	34	<i>(Outdoor-Indoor Transmission Class)</i>

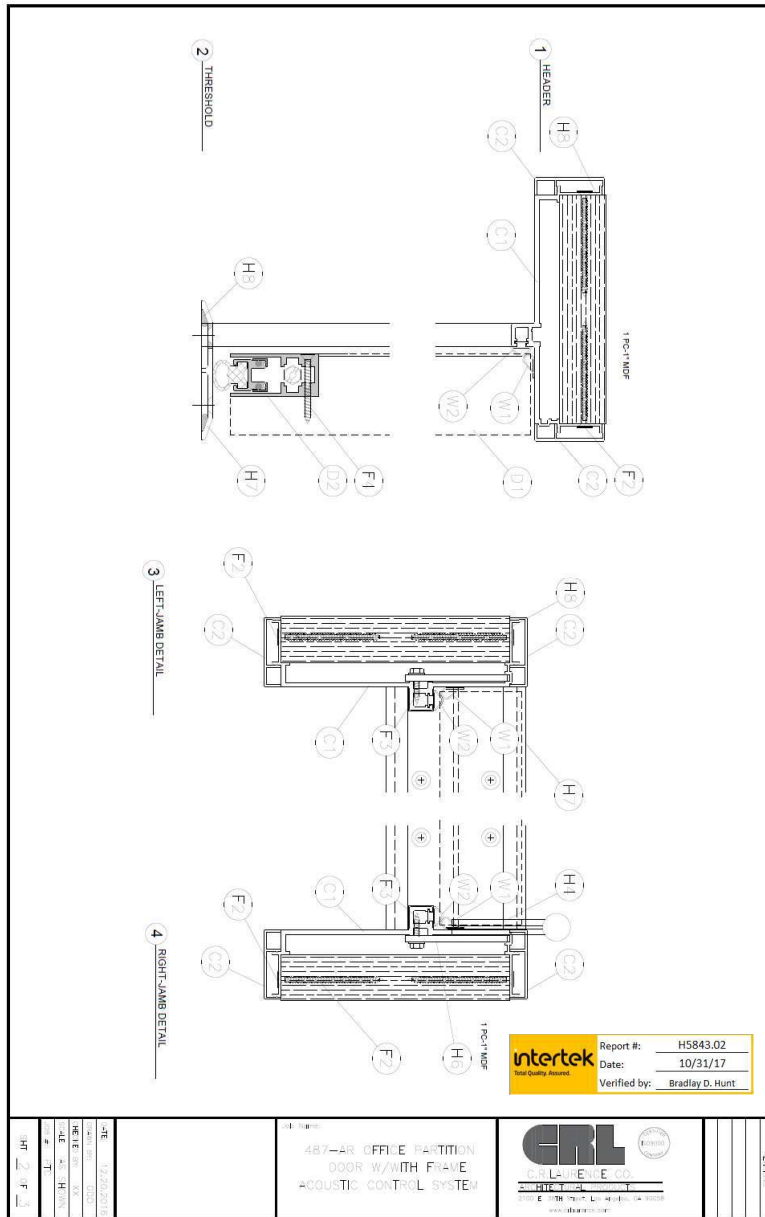
**SECTION 12
DRAWINGS**

ITEM #	PART #	DESCRIPTION
1	1	DOOR
2	2	FRAME
3	3	FASTENERS
4	4	WITH STRIP
5	5	DOOR
6	6	HARDWARE

487-AR OFFICE PARTITION
DOOR W/ WITH FRAME
ACOUSTIC CONTROL SYSTEM

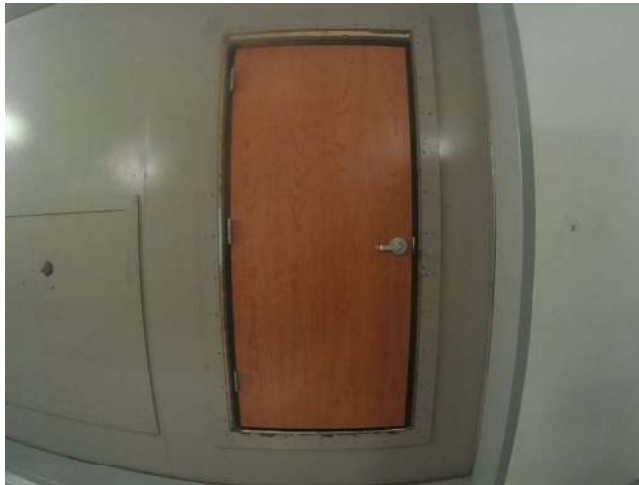
Receive Room View of Test Specimen

The specimen plug was removed from the filler wall assembly. The specimen was placed on an isolation pad in the test opening. Duct seal was used to seal the perimeter of the specimen to the test opening on both sides. The interior side of the specimen, when installed, was approximately 1/4" from being flush with the receive room side of the filler wall. A stethoscope was used to check for any abnormal air leaks around the test specimen prior to testing. Operable portions of the test specimen, if any, were cycled at least five times prior to testing.

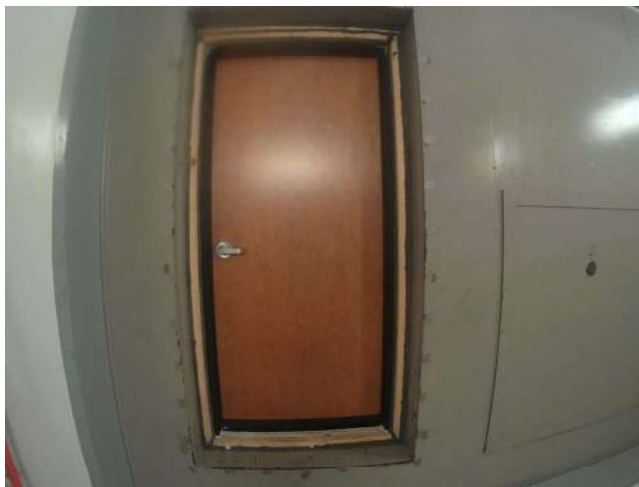
Source Room View of Test Specimen
